***Seawall Evaluation Report  
Kinnickinnic River, Wisconsin  
Milwaukee Estuary Area of Concern  
Sediment Removal Concept Design***

***Prepared for  
U.S. Army Corps of Engineers  
Detroit District***

***July 2003***

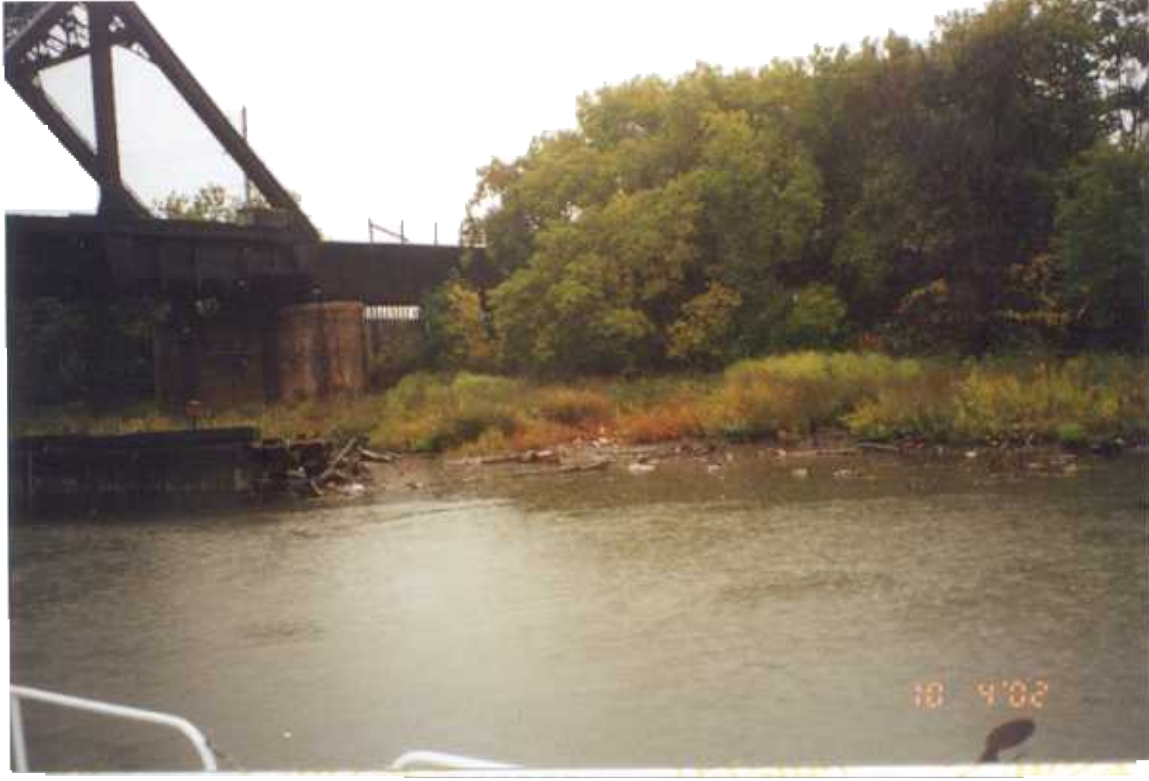
PHOTO 70 – October 4, 2002 – Kinnickinnic River  
Taken by Tor Hansen, Barr Engineering  
Vegetation along shoreline at Parcel 441. Downstream from photo 69. Looking south.

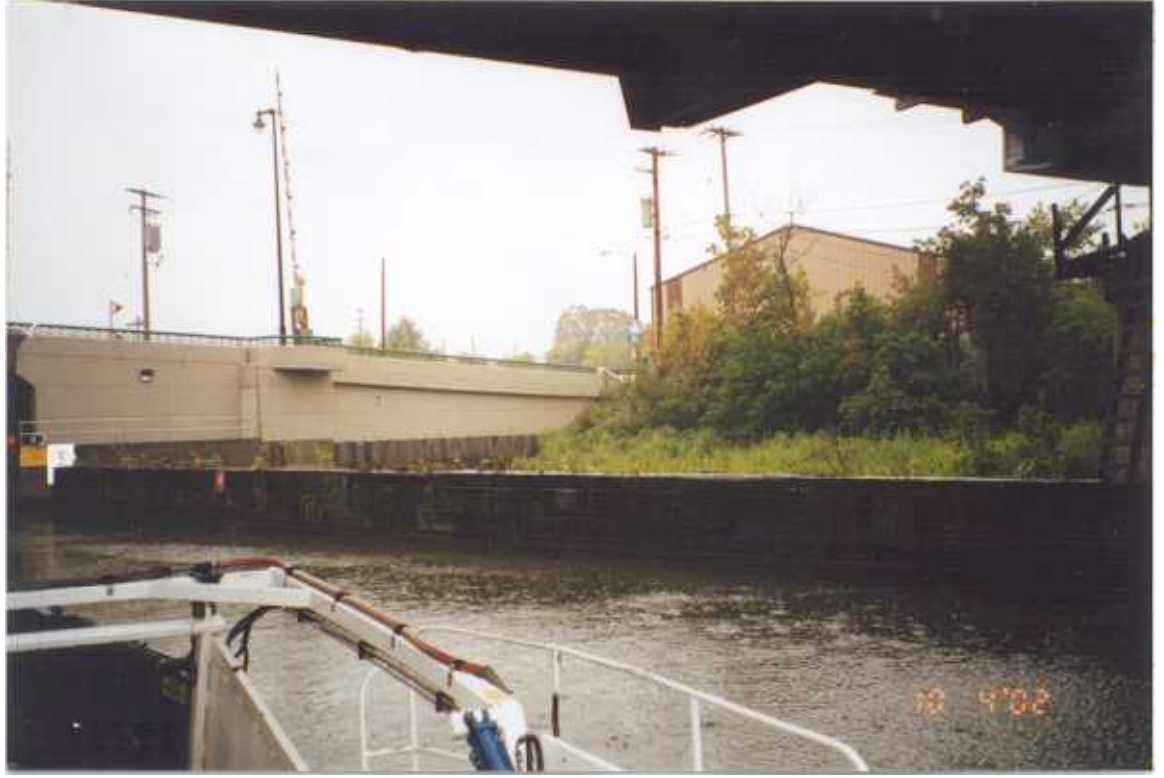
PHOTO 73 – October 4, 2002 – Kinnickinnic River  
Taken by Tor Hansen, Barr Engineering  
Upstream side of Kinnickinnic Avenue Bridge and left abutment.  
Looking east.
